**Latah Soil and Water Conservation District
Meadow Restoration Vegetation Monitoring Summary
November 2021**

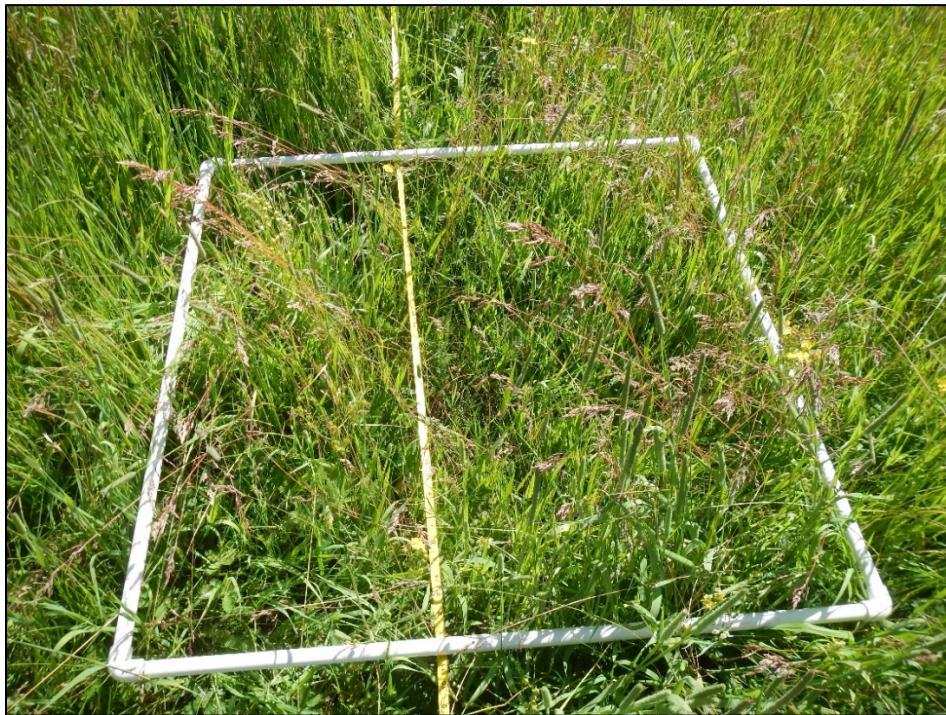
Figure 4. Five-Acre Meadow, Transect 2, Frame 2, June 28, 2016 – 1-year post-construction. Dry site pasture grasses like timothy (*Phleum pratense*) and Kentucky bluegrass (*Poa pratensis*) are the dominant species.

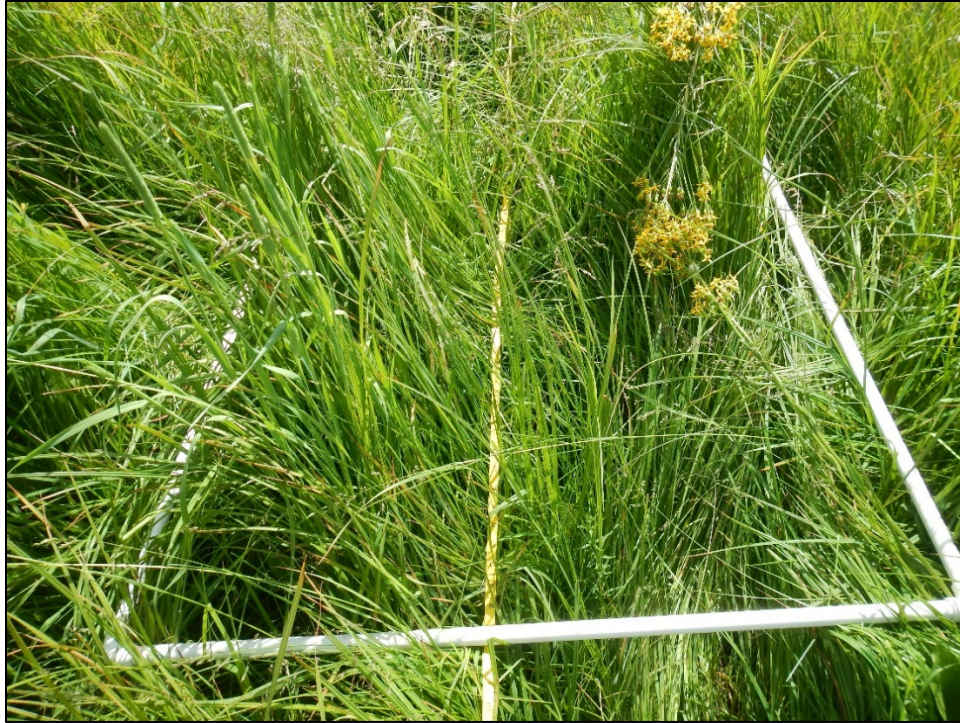
Figure 5. Five-Acre Meadow, Transect 2, Frame 2, June 26, 2020 – 5-years post-construction. Note transition to sedge-dominated plant community.

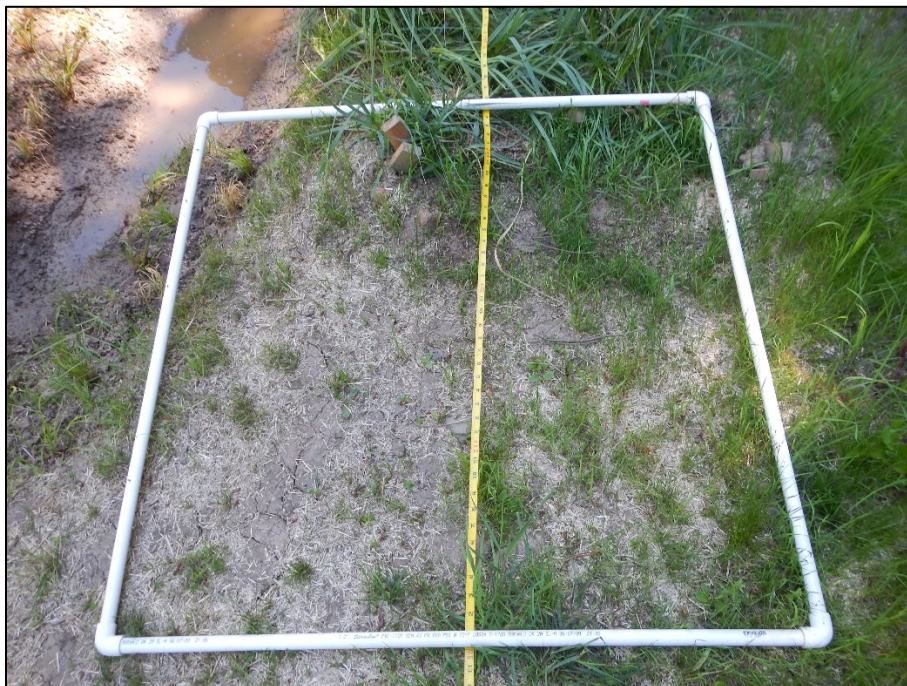
Figure 8. Vassar Meadow along West Fork Corral Creek, Transect 3, Frame 3, June 28, 2016 – 1-year post-construction. Note that Latah SWCD seeded and mulched areas disturbed by construction activities. This frame provides an example of such an area.

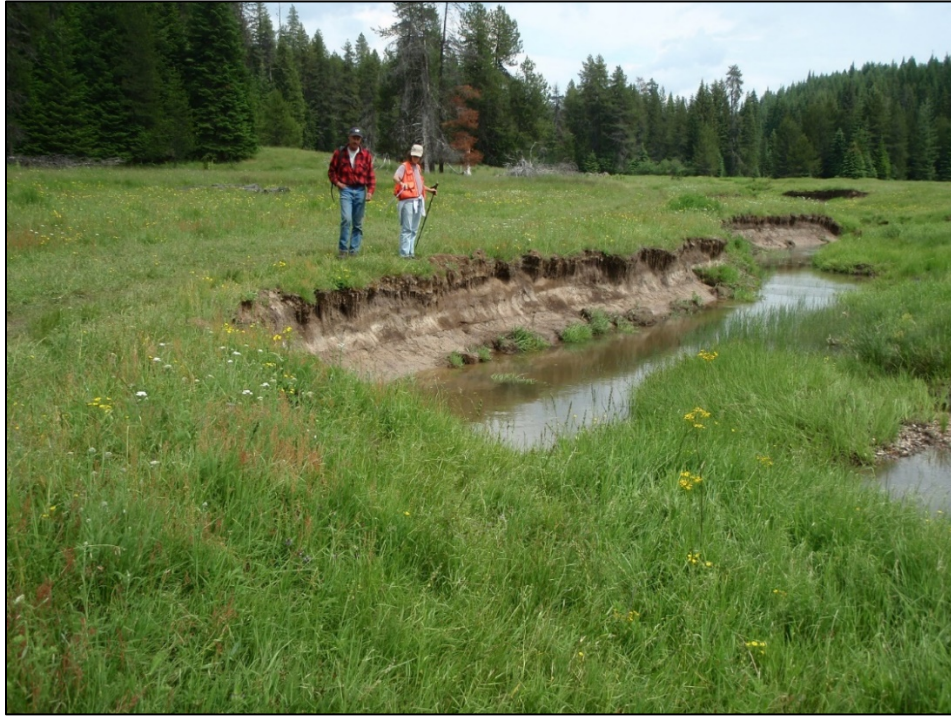
Figure 10. Corral Creek ditch through Colby Meadow, June 15, 2009, pre-construction. Note lack of floodplain access in incised and eroding ditch that conveyed most of the flow for Corral Creek before the diversion into the historic alignment.

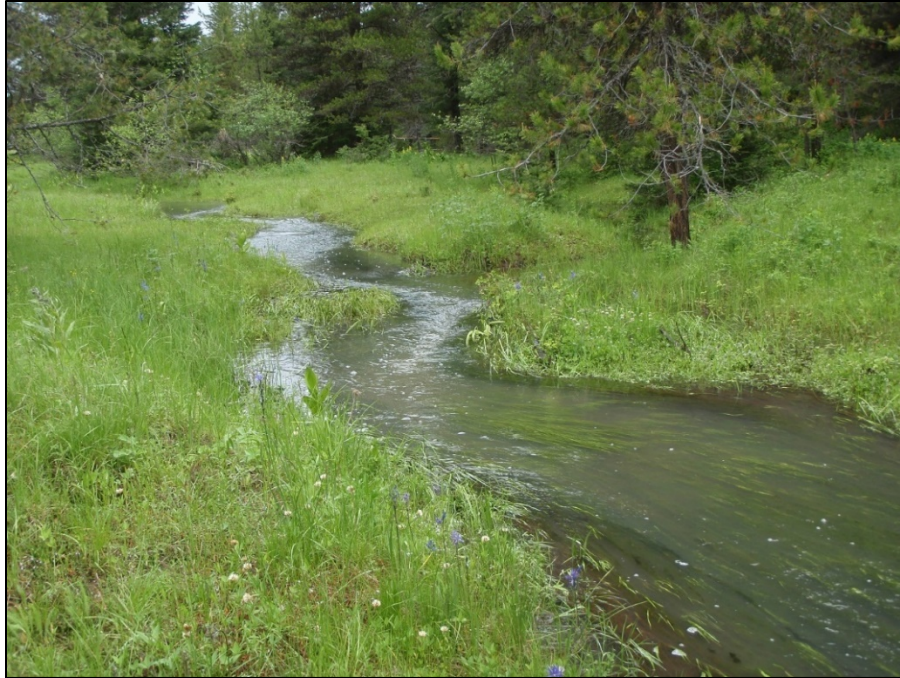
Figure 11. Corral Creek in Colby Meadow, June 10, 2010, 1-year post-construction. Corral Creek with flow following flow diversion from incised ditch and into historic channel alignment.

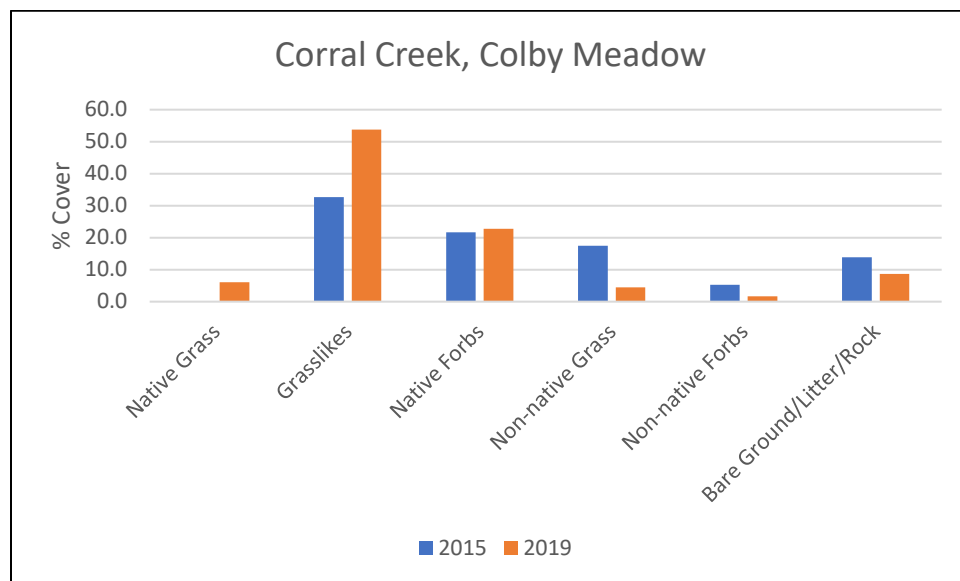
Figure 12. Colby Meadow vegetation data summary.

One notable change in the Colby Meadow plant community was an increase in grasslikes from 6- to 10-years post-construction (Figure 12). Although there is no baseline data for this site, the Latah SWCD project planner indicated that this meadow was highly degraded prior to meadow restoration efforts (Trish Heekin, Latah SWCD pers. comm. 2021). At Tee Meadow, grasslikes and native grasses are also increasing which corresponded with a decline in native forbs (Figure 15). Both Colby and Tee meadows currently have an active grazing program, and meadow restoration protection strategies include cattle exclusion fencing in the riparian zone. Meadow dehydration that resulted from channel incision and floodplain disconnection coupled with concentrated, season long grazing contributed to the degradation of the plant community. Restoring functionality to the meadow via process-based meadow restoration (Beechie et al. 2010) along with the addition of cattle exclusion fencing, development of upland off-site watering, and an increase in early-season standing water throughout the meadow (cattle don't like to get their feet wet) has reduced grazing pressure during the wet and most sensitive times.

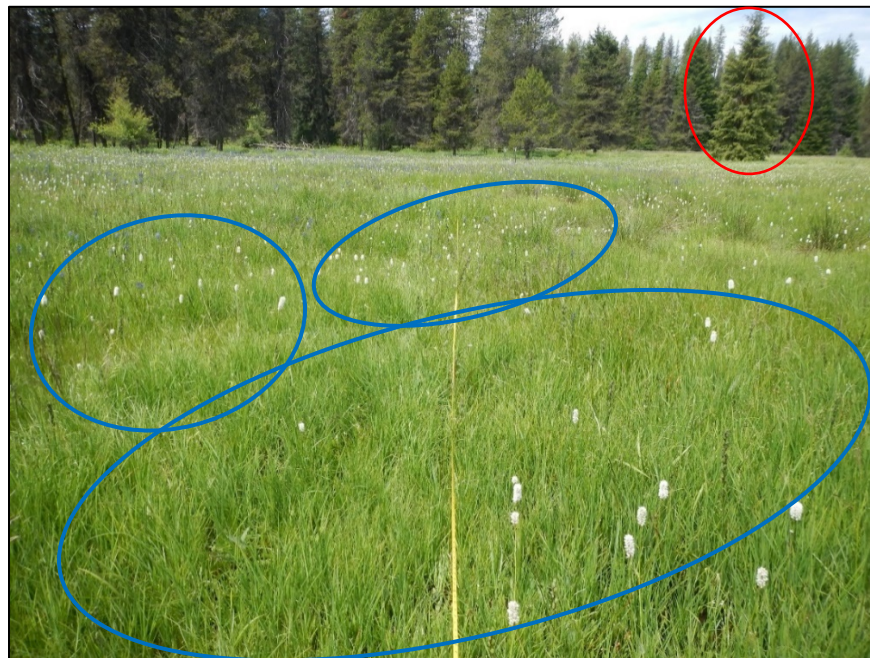
Figure 14. Colby Meadow Transect 3, June 5, 2019, 10 years post-construction. Note the clumps of sedges from 2015 have expanded into a mat formation, blue circles for comparison with previous photo. These photos were taken 3 weeks later than the 2015 pictures, but the phenology of the American bistort, which is the white-flowering plant, shows that we are within a similar stage in the season to allow for a good comparison of the plant community. Red circled tree for repeated photo comparison.

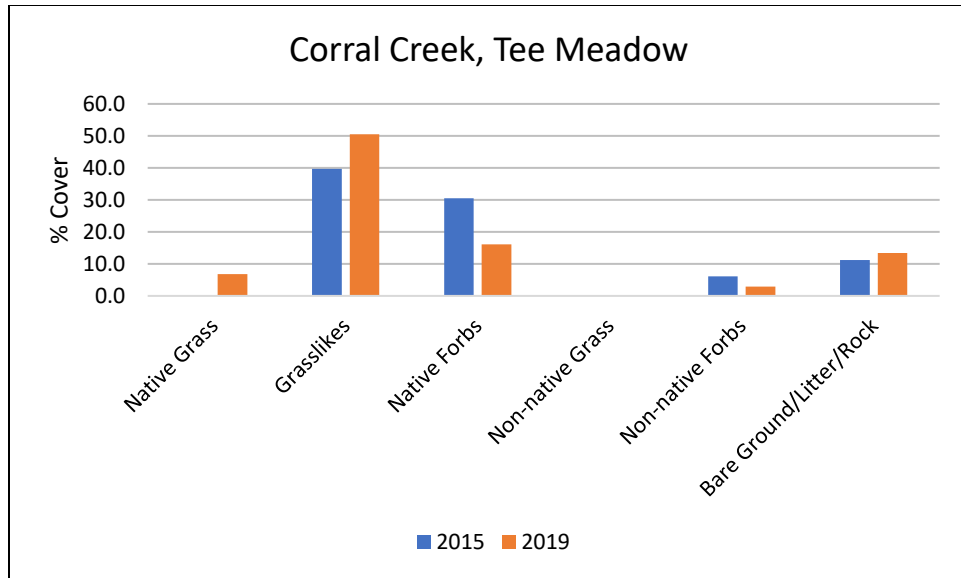
Figure 15. Tee Meadow vegetation data summary.

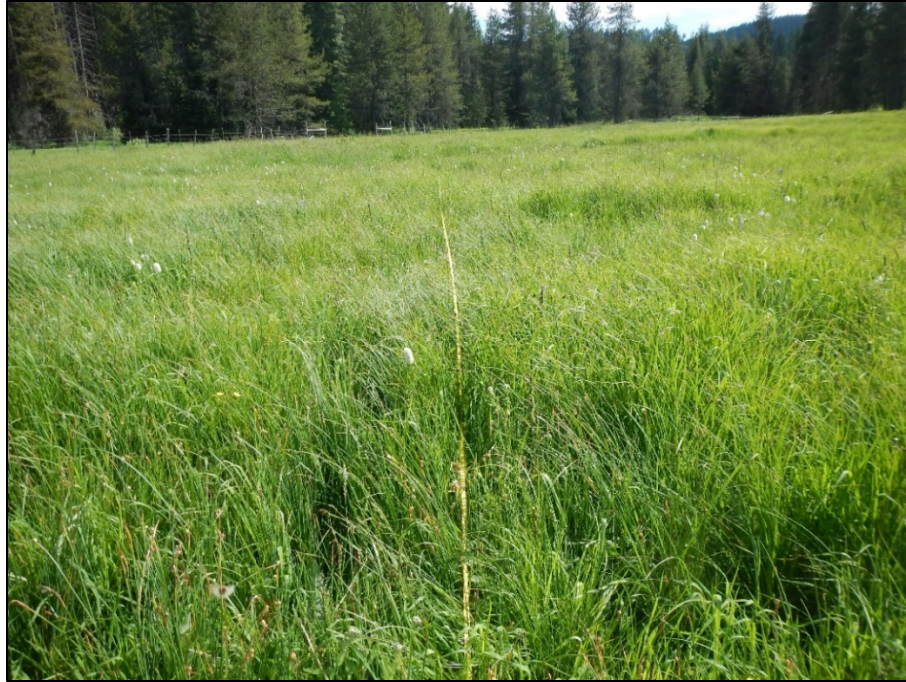
Figure 17. Tee Meadow, Transect 3, June 5, 2019, 10 years post initial construction. Beaver Dam Analogs (BDA) were installed in 2016 to expand floodplain access and enhance meadow hydration. Increased meadow rehydration is evident in this photo based on the increase in grasslike species.

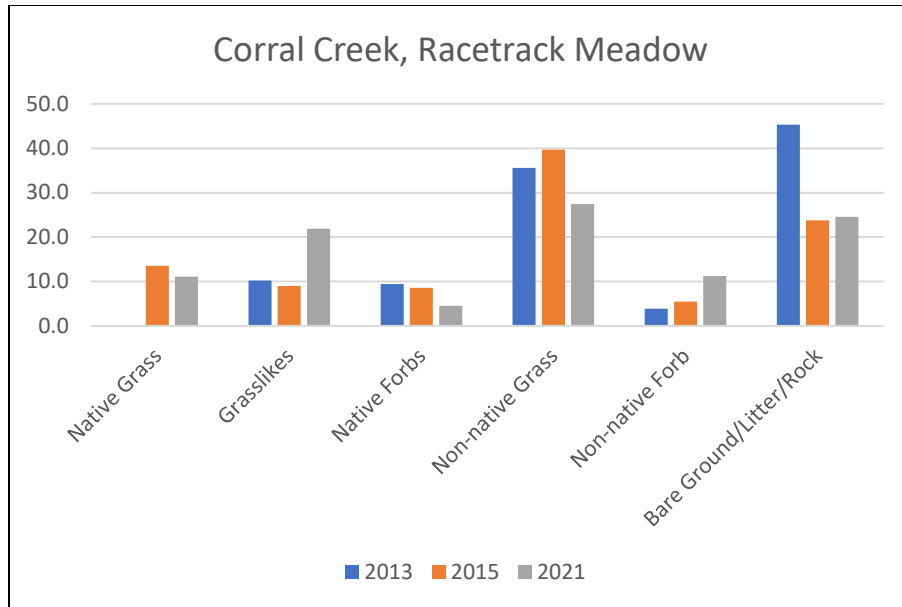
Figure 18. Racetrack Meadow vegetation data summary.

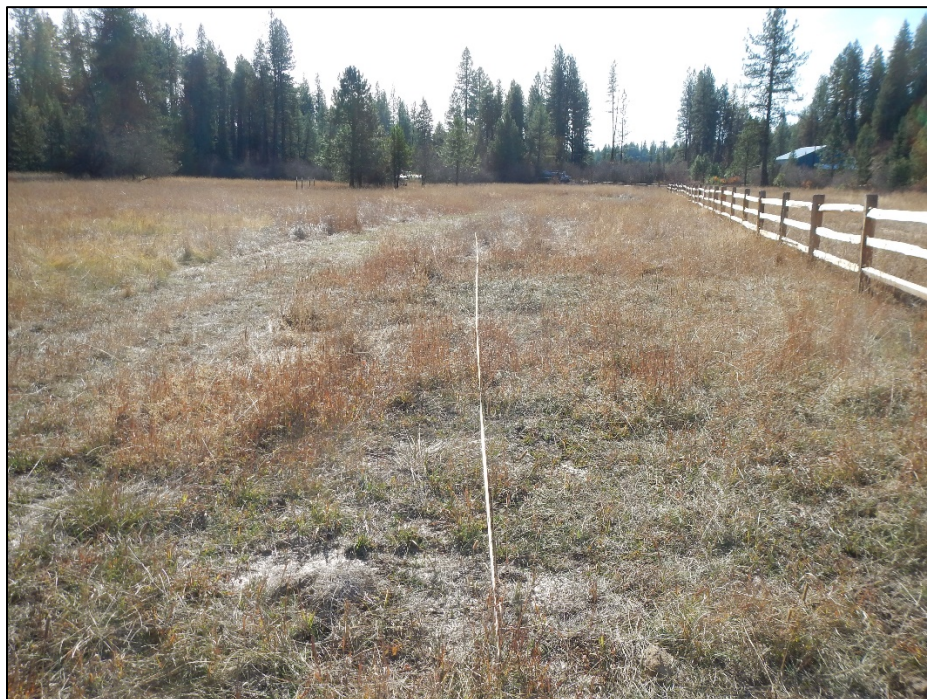
Figure 19. Racetrack Meadow, Transect 1, October 22, 2015. Note bare ground extent and sparse vegetation. This transect is located outside of the livestock exclosure fencing.

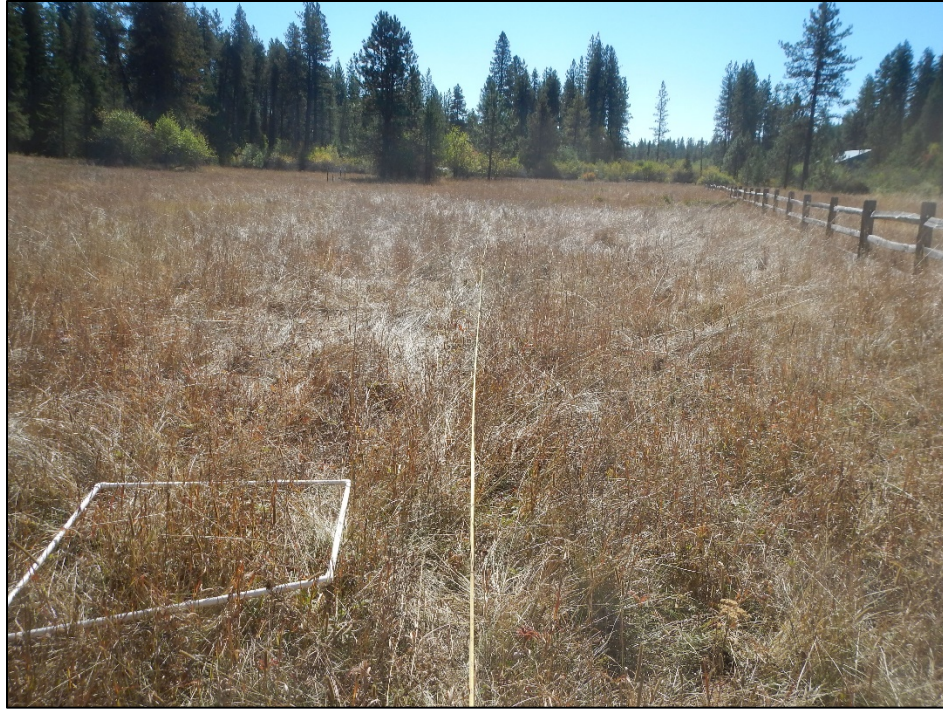
Figure 20. *Racetrack Meadow, Transect 1, September 16, 2021. Note grasses and sedges have increased in spite of the transect being located outside of the exclosure fencing. Much of the vegetation visible is sedge with some native and non-native grasses mixed in.*

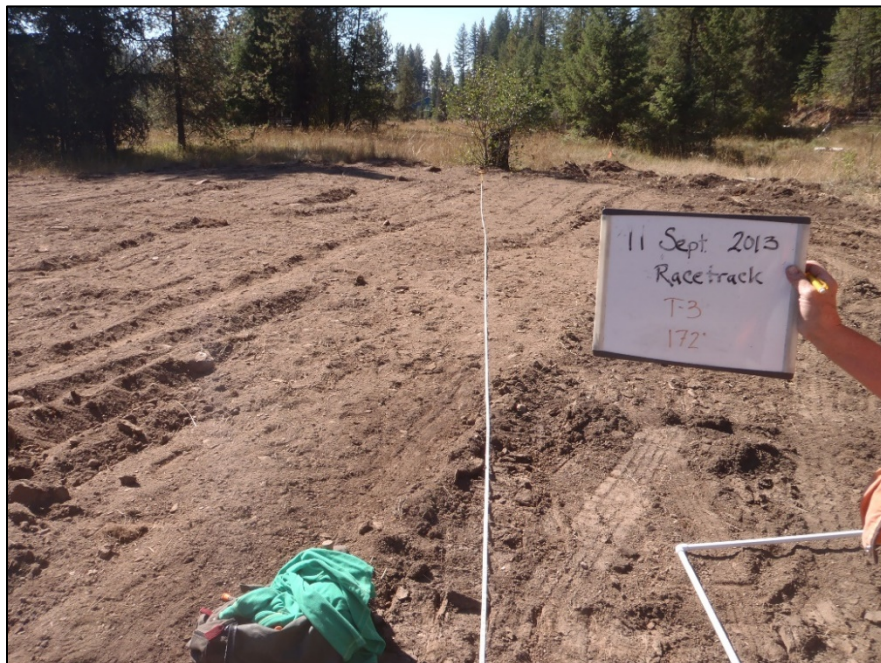
Figure 21. *Racetrack Meadow, Transect 3, September 11, 2013. Monitoring site to showcase revegetation efforts on disturbed location within a meadow restoration project site. Site is within livestock exclusion fencing.*

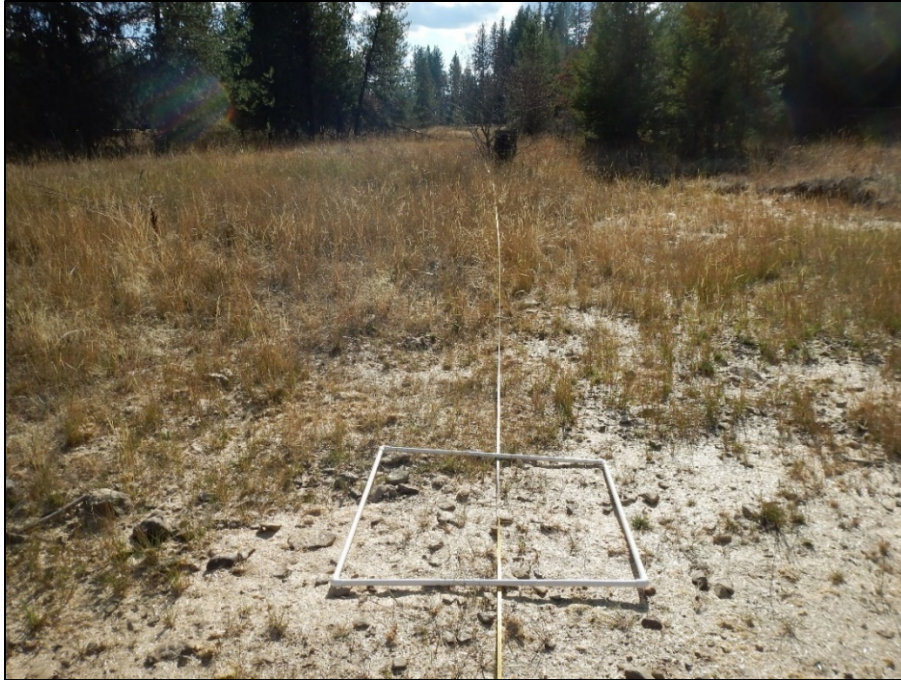
Figure 22. Racetrack Meadow, Transect 3, October 22, 2015 (2 years post-construction). Note seeded and mulched areas in the foreground as revegetation process continues. Taller grasses in the background are native perennial grasses seeded directly following construction in fall 2013. Most vegetation visible is meadow barley (*Hordeum brachyantherum*).

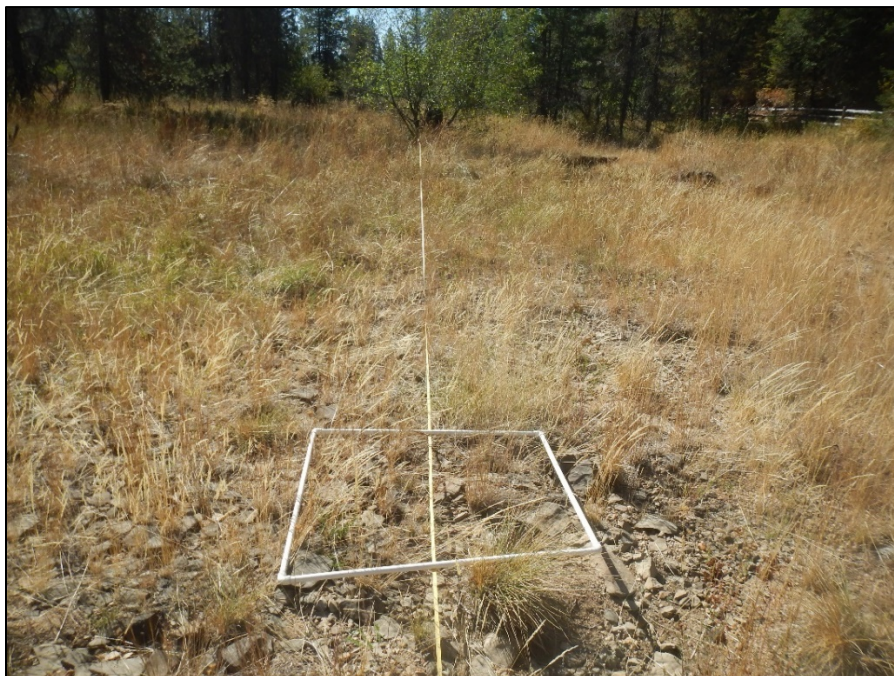
Figure 23. Racetrack Meadow, Transect 3, September 16, 2021 (8 years post-construction). Note that bare ground continues to decline at this transect site in spite of the the rocky soil conditions.

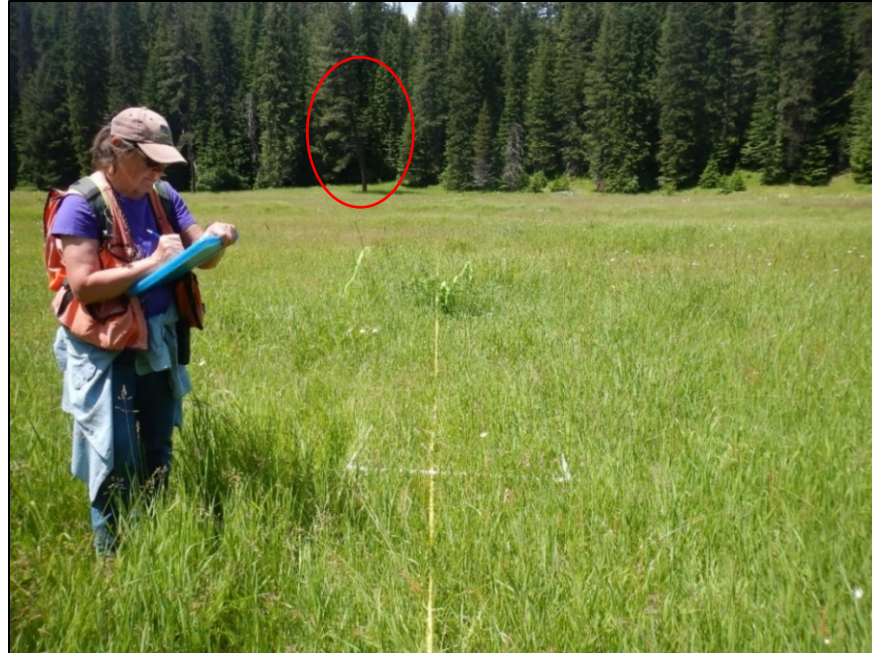
Figure 25. Two Mile Meadow, Transect 3, June 12, 2018, pre-construction. Transect vegetation dominated by non-native pasture grasses. Red circled tree for repeated photo comparison.

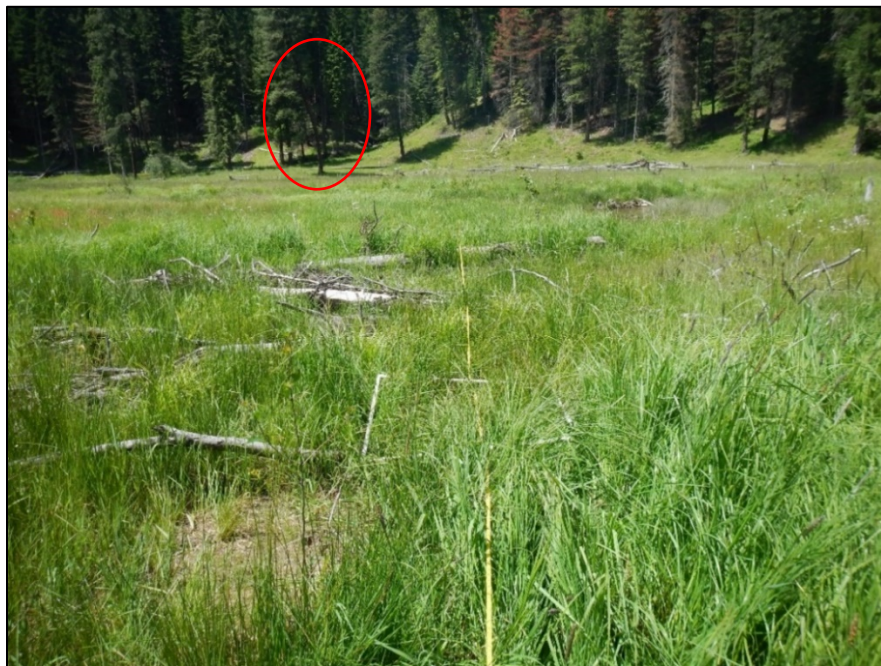
Figure 26. Two Mile Meadow, Transect 3, June 19, 2020, 2-years post-construction. Grasslikes increased from 18% pre-construction to 57% just 2 years post-construction at this transect. Wood/slash visible in this photo was placed on the floodplain for roughness following construction. Slash slows and disperses flow across the meadow and provides microsites for seeds and plants which aids in revegetation success. Red circled tree for repeated photo comparison.
