Project Title: Corral Creek Wetland and Riparian Restoration Tee / Colby Meadows Reach

Project Type: Fisheries/Steelhead Habitat Restoration, Threatened Ecosystems/Wetlands Restoration [see Latah SWCD Five-Year Plan]

Location: Corral Creek, a tributary of the Potlatch River, in Latah County, Northern Rockies Ecosystem [see the Latah SWCD Potlatch River Watershed Management Plan, under Reports and Plans, at www.latahswcd.org]

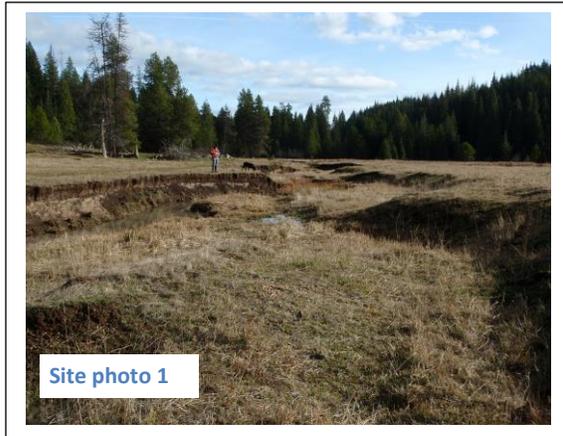
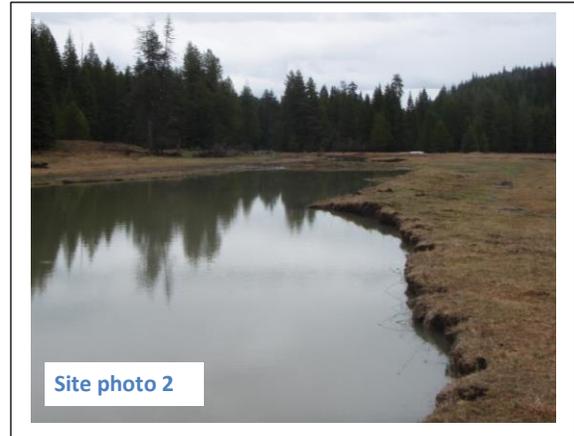
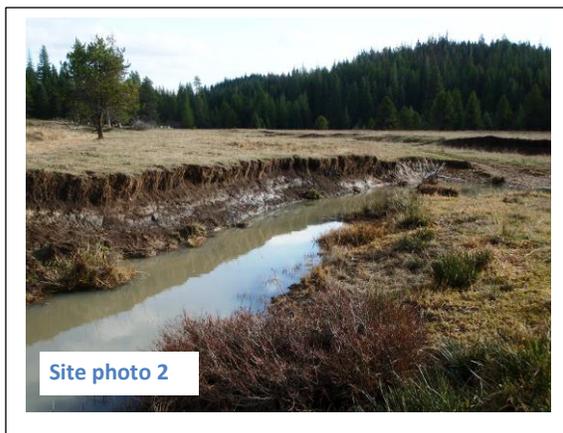
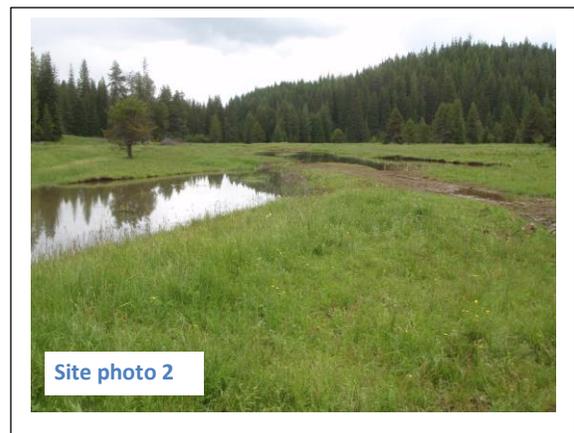
Two repair sites in Colby Meadow. Ditch plugs were installed in the eroding ditch to create wetland cells to reduce erosion, increase infiltration, and create wildlife habitat. Before on left; after on right.

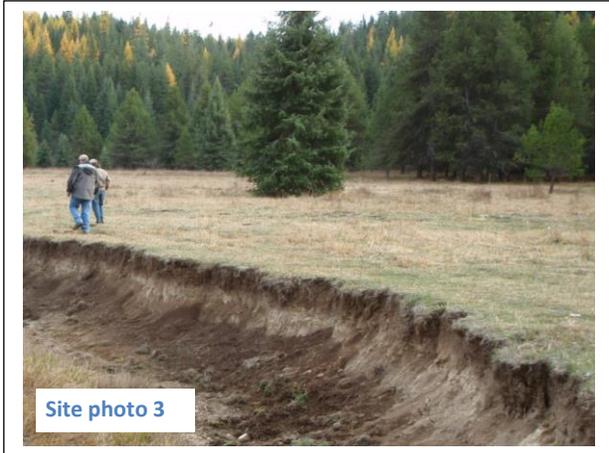
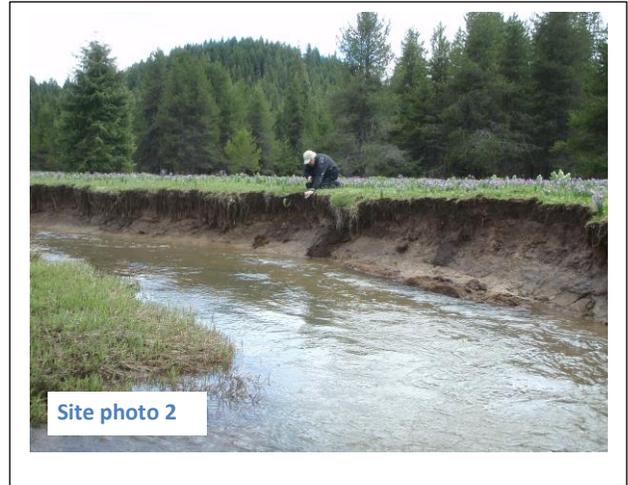
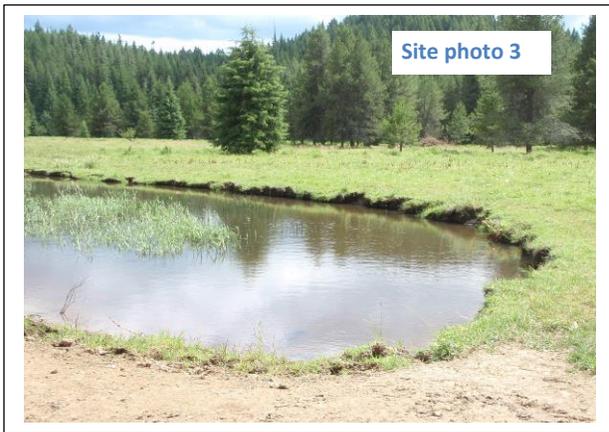
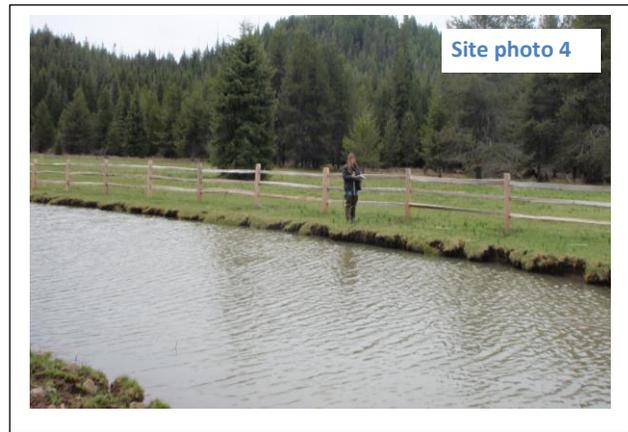
Repair site in Colby Meadow. Ditch plug 8 (foreground in site photo 3) was installed in the ditch to create wetland cells to reduce erosion, increase infiltration, and create wildlife habitat. Top two photos show prior condition; site photo 3 was taken the spring following completion of the ditch plug; site photo 4 taken the following fall, following installation of livestock exclusion fencing.

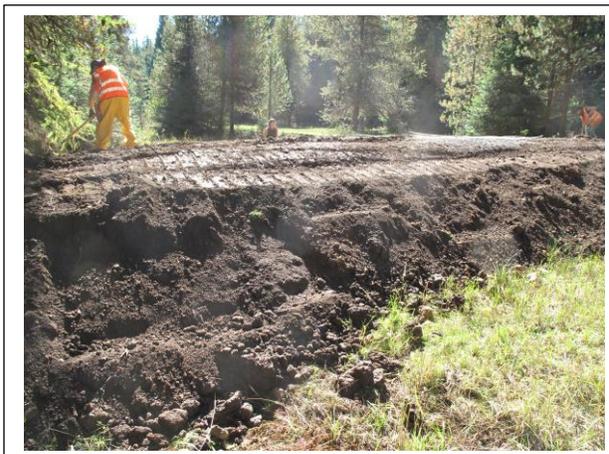
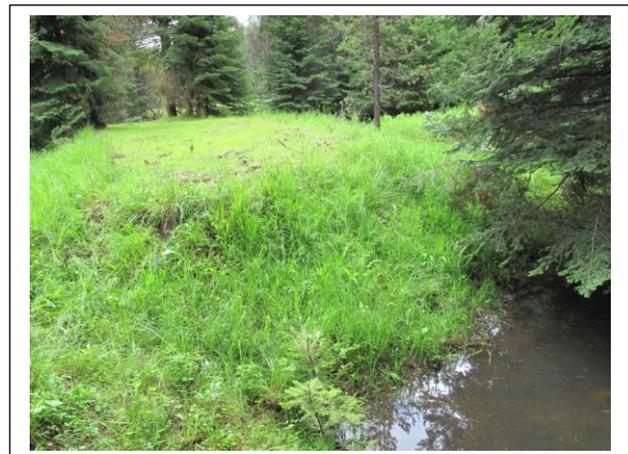
Left, newly-constructed ditch plug. On right, ditch plug the first spring following construction: sedge sodmats were laid on the face of the plug and the top was seeded and mulched.

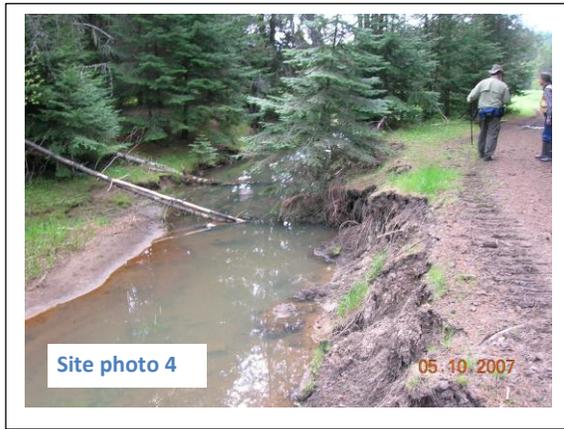
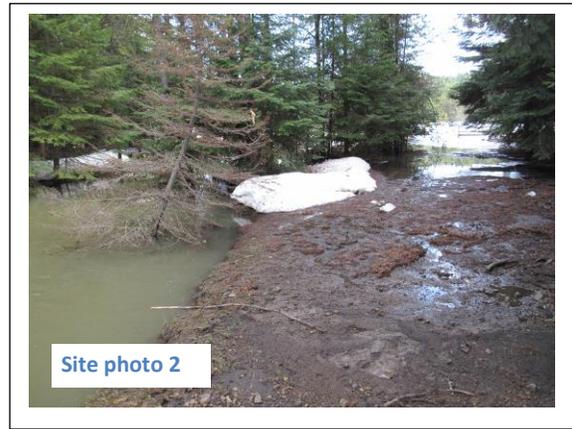
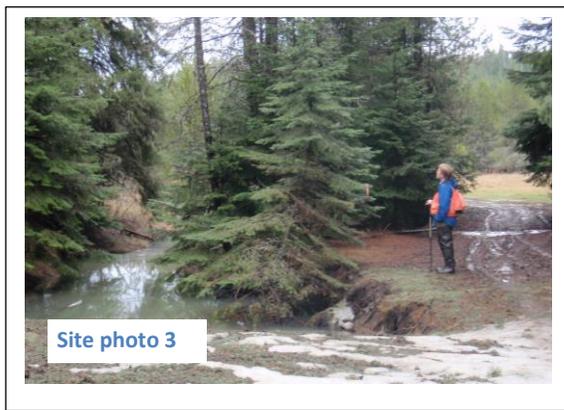
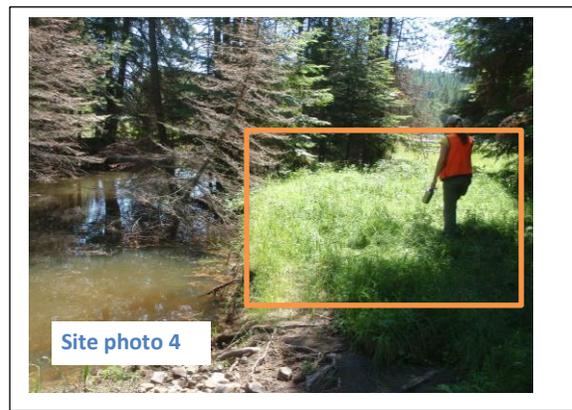
Repair site along private road, which was later decommissioned. Ditch plugs have been installed upstream and downstream of this location to reduce erosion and create wetland habitat. Site photo 1 is before construction; Site photo 4 was taken in July 2012. The eroding right bank in site photo 4 was covered with sedge sodmats in fall 2011.

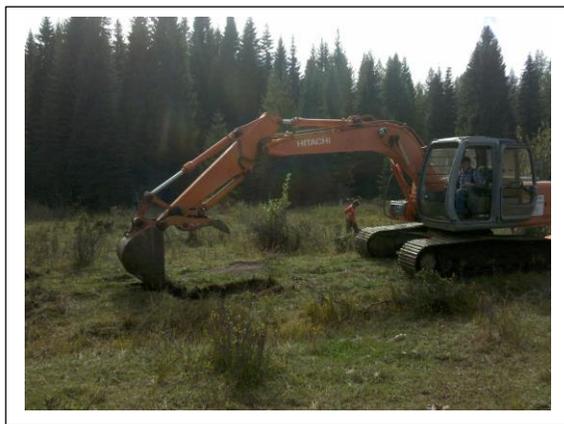
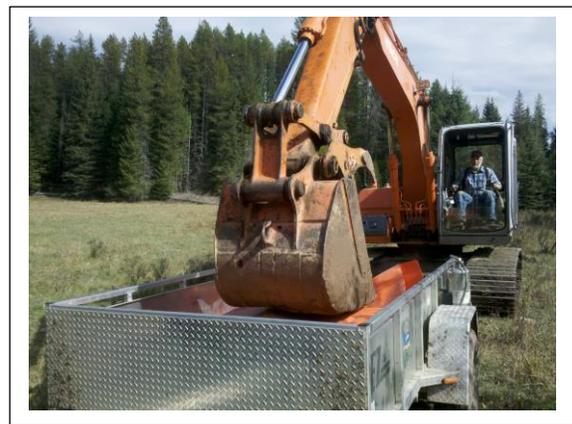
Harvesting sedge. Sedge sodmats were used to revegetate the slopes of the ditch plugs and other eroding sites. Sedge was transported to site in layers in the trailer, then pulled off and placed by hand, jig-saw fashion, to cover the bare soil.
