Project Title:	Corral Creek Wetland and Riparian Restoration Avulsion / Round Meadow Reach
Project Type:	Fisheries / Steelhead Habitat Restoration, Threatened Ecosystems / Wetlands Restoration [see Latah Soil and Water Conservation District's Five-Year Plan]
Location:	Corral Creek, a tributary of the Potlatch River, in Latah County, Idaho, Northern Rockies Ecosystem [see Latah SWCD Potlatch River Watershed Management Plan, under Plans & Reports, at www.latahswcd.org]
Ownership:	Private land
Sponsor:	Latah Soil and Water Conservation District
Supporters:	Landowner Idaho Office of Species Conservation / Pacific Coast Salmon Recovery Fund [link] Idaho Department of Environmental Quality / EPA Clean Water Act Funding Bonneville Power Administration / NOAA Fisheries Funding [link]
Project Description:	<p><u>Problem:</u> Legacy effects of logging, with associated construction of railroad spur lines, and livestock grazing, had degraded water quality and fish habitat. After a passage barrier downstream was removed in 2007, spawning steelhead (ESA listed threatened) regained access to the upper Corral Creek watershed, including this reach [link to Clearwater Subbasin Plan, link to Idaho Dep

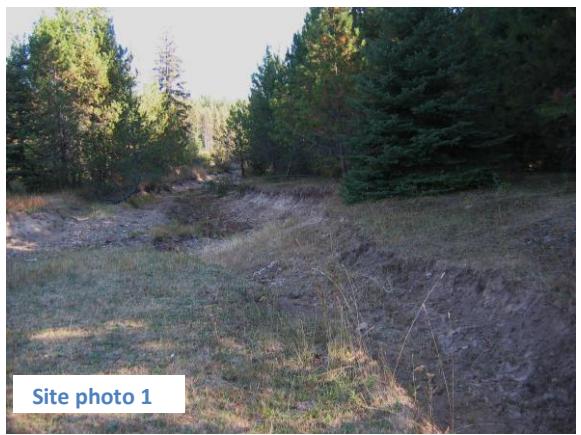
Avulsion Reach: Avulsed channel (ditch) repaired by diverting flow back into historic channel and converting ditch to wetland cells in order to reduce erosion and improve meadow hydrology by prolonging infiltration. Added roughness features and revegetated.

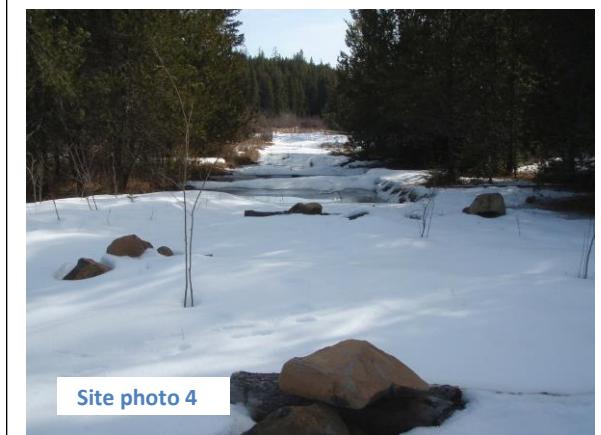
Avulsion Reach: Diversion ditch plug, used to divert flow out of ditch, back into historic channel
vegetate with sedge sod mats.
