# Passage Barrier Removal: Habitat Restoration in the Potlatch River Watershed

## Passage Barrier Removal

Project Type:	Fisheries/Steelhead Habitat Restoration, Threatened Ecosystems/Wetlands Restoration [see the Latah Soil and Water Conservation District Five-Year Plan]
Location:	Corral Creek, a tributary of the Potlatch River, in Latah County, Northern Rockies Ecosystem [see the Latah Soil and Water Conservation District Potlatch River Watershed Management Plan, under Plans & Reports, at <a href="http://www.latahswcd.org">www.latahswcd.org</a> ]
Ownership:	Public land, surrounded by private land
Supporters	Landowner (Idaho Department of Lands) and adjacent private landowners Idaho Department of Fish and Game USDA Natural Resources Conservation Service / Wildlife Habitat Incentive Program, Salmon Initiative [link] Idaho Office of Species Conservation / Pacific Coast Salmon Recovery Fund [link] Idaho Department of Environmental Quality / EPA Clean Water Act Funding Idaho Soil and Water Conservation Commission Bonneville Power Administration / NOAA Fisheries Funding [link]

Summary prepared by Trish Heekin, Resource Conservation Planner, Latah Soil and Water Conservation District,

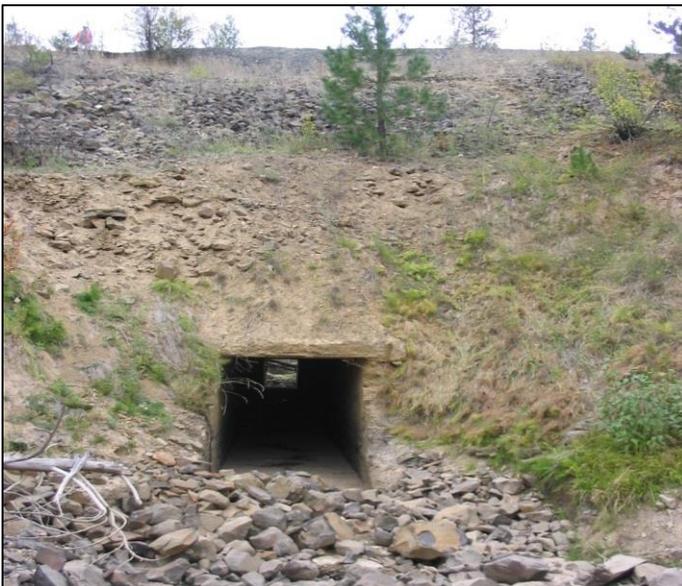
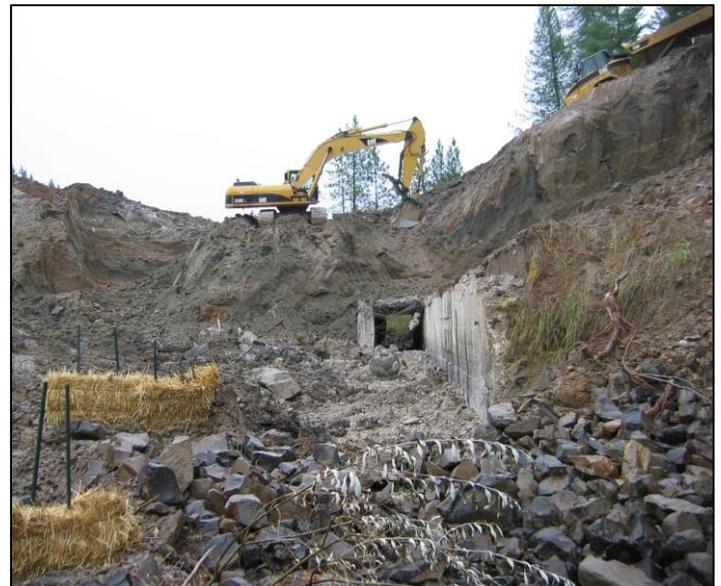
**Construction:** Timber on top of the embankment was removed. 49,000 cubic yards of fill around and above the culvert was removed and deposited elsewhere along the abandoned railroad right of way. The culvert was broken into pieces, removed and disposed of. A new channel was created and embankments from the old railroad elevation to the creek sloped and terraced.

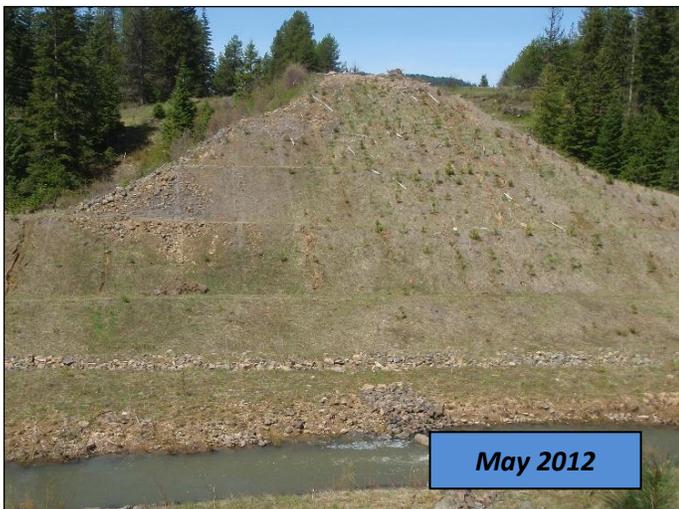
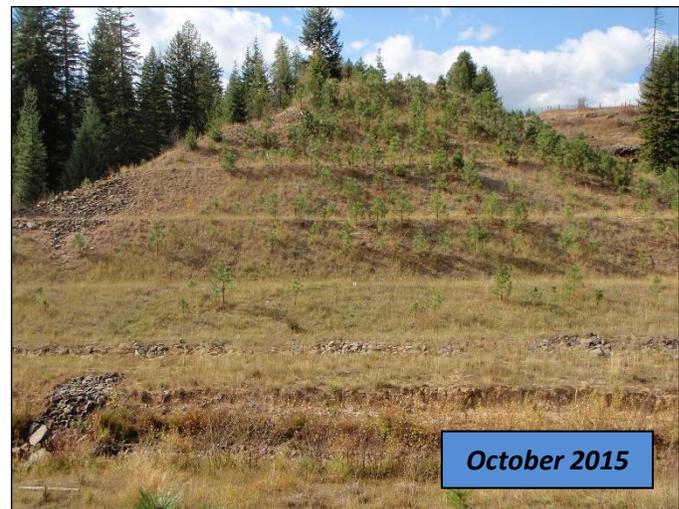
**Revegetation:** Immediately following construction the floodplain, fill disposal areas, and terraces were seeded and mulched with 370 pounds native seed. Erosion control material (90,000 square feet) was applied to the terraced slopes. Between 2007 and 2013 approximately 27,000 containerized plants and cuttings were put in along the channel and on the floodplain, slopes and disposal areas.

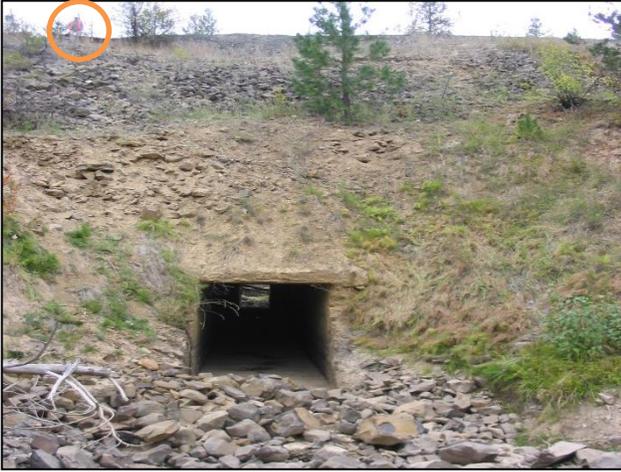
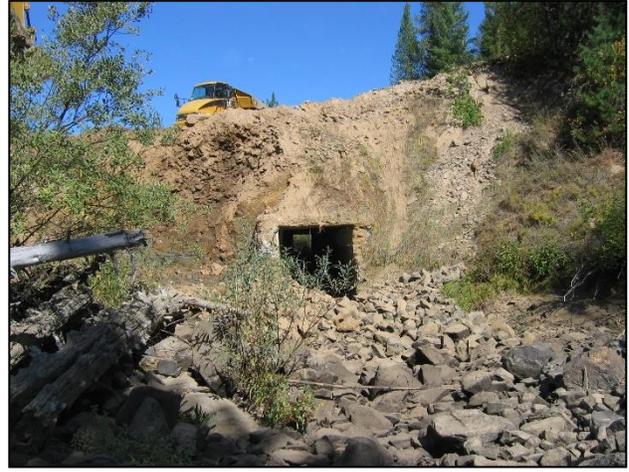
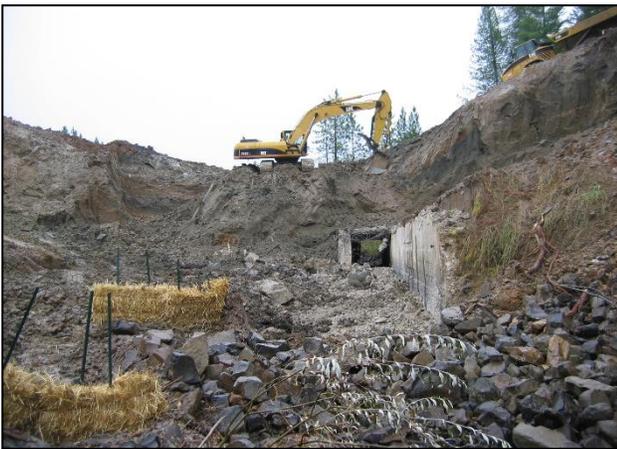
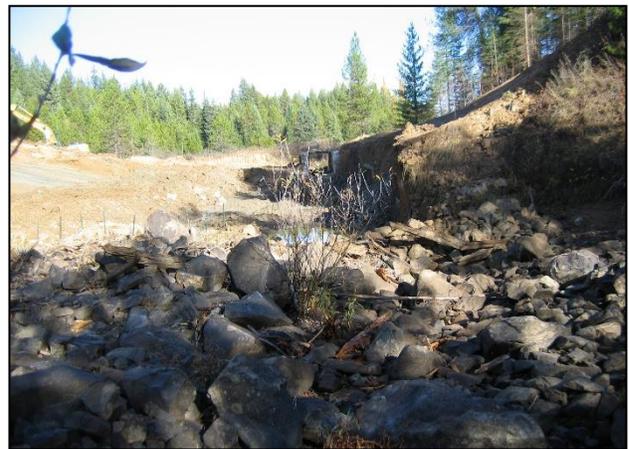
Above: Culvert was a [velocity] barrier to fish passage. Note the person in the orange vest standing at the top of the fill in the top left photo (height of embankment was 67 feet). Fill and culvert were removed in fall 2007.

Installed in 1913, a 200-foot long concrete box culvert was placed within a 67-foot high embankment to support a main rail line used to transport logs and lumber. The smooth surface and length of the run through the culvert created a velocity barrier and blocked passage for migrating fish. As a consequence, the upper 75 percent of the watershed, approximately 15 miles of 4<sup>th</sup> order stream habitat was not accessible to Steelhead for spawning and rearing. In 2007 the culvert and fill were removed and revegetation efforts began. In August 2008, the first year following removal of the passage barrier, juvenile Steelhead were detected during fish surveys in Smith Meadows, several miles upstream of the former barrier.

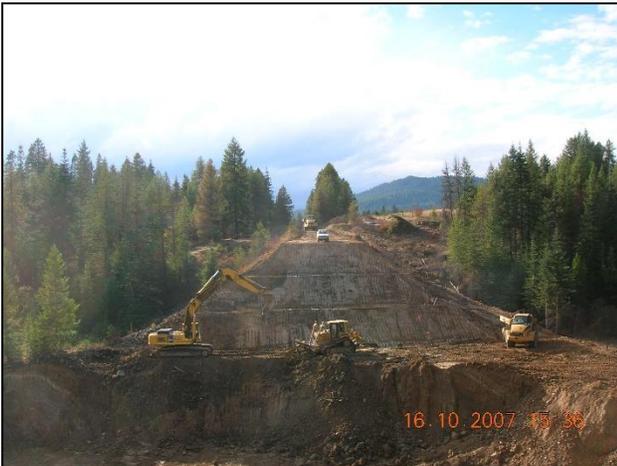
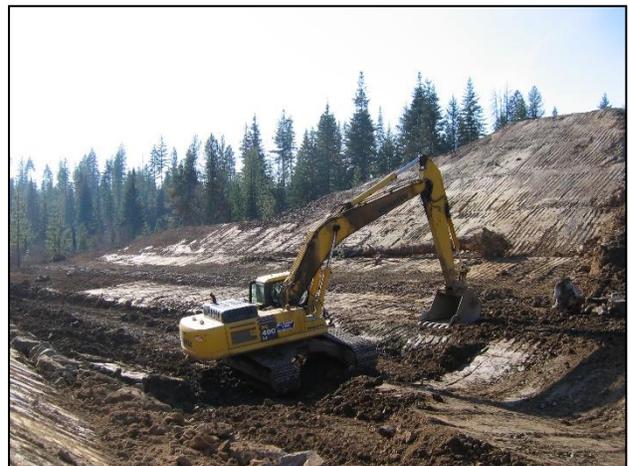
Below: Removal of fill and culvert involved 2 belly-scrappers, 2 bulldozers, 3 excavators, 6 articulating dump trucks, and a wrecking ball. Excavator at right below is cutting terraces and new channel.

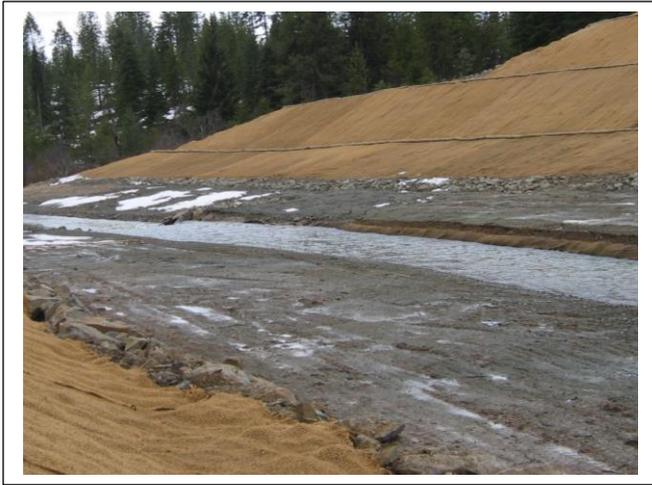
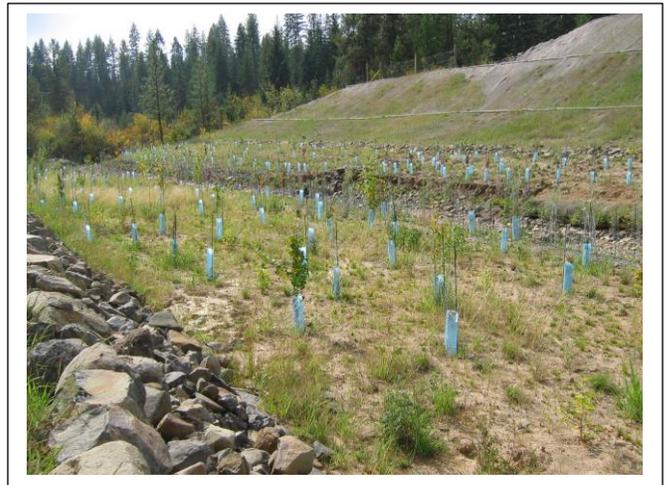
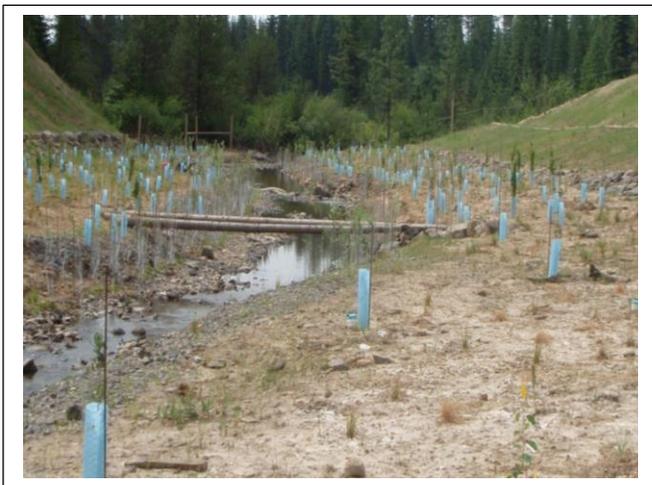
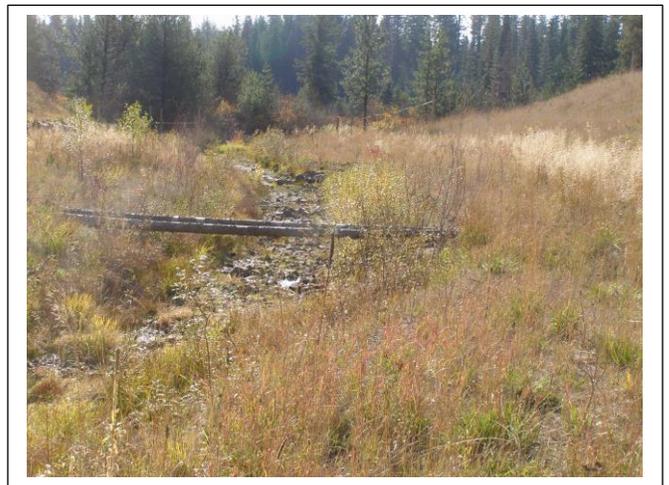
Revegetation included seeding, mulching, application of erosion control material, planting, installing plant protection, and control of invasive weeds.
